Manhole Inspection Summary

Manhole # S19A1_016MH

Insp Date: **6/2/08 8:37 AM**

Location Address: **2136 whistler av** Cross Street: **tolley-paca alley**

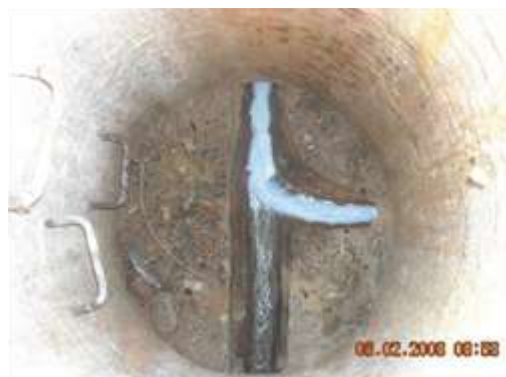
misc

inflow evidence from sheeting

bench debris

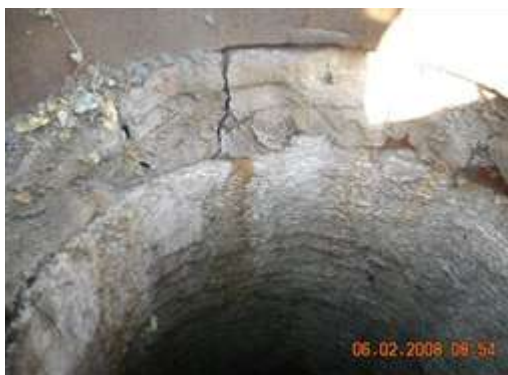
Defect 4

Infiltration: ☐ None ☒ Joint ☐ Cracks ☐ Mortar ☐ Roots ☐ Wall

infiltration @ corbel/chimney joint,
chimney parged

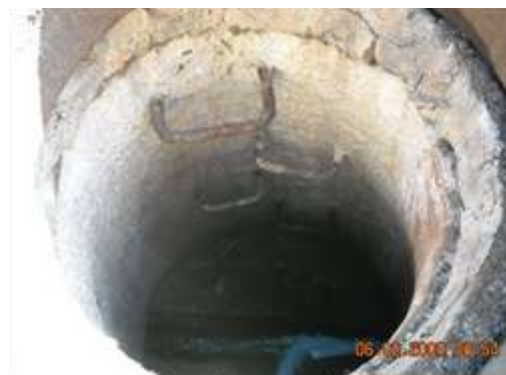
Defect 3

Steps Count: **4** Missing: **0** ☒ Corroded

corroded steps

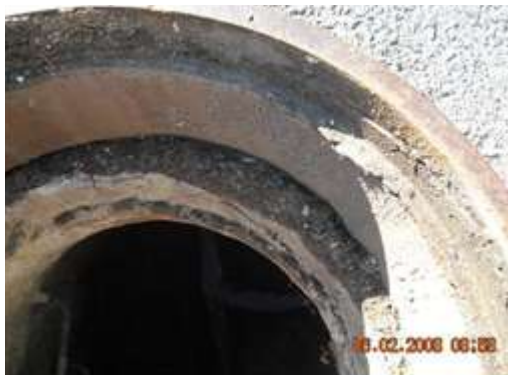
Defect 1

Frame Offset: **2** (in.) Condition: ☒ Sound ☐ Cracked ☐ Leaks

frame offset

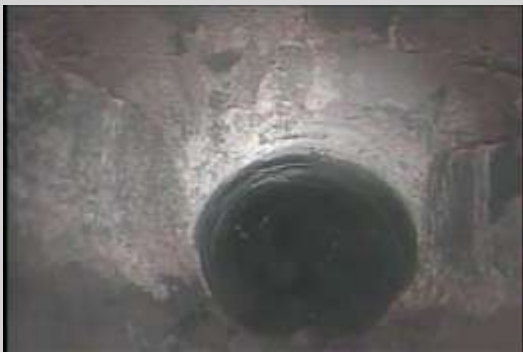
12 O'Clock Outflow

8 in. Circular Gravity Sewer
Pipe Out @ 12 O'Clock

Pipe Height: **8.4** (in.) Rod and Bar (Angled)
Pipe Material: **Clay** ☐ Pipe Lined
Invert Depth: **8.56** (ft.) Flow Characteristics: **Slow**
Deposits: ☒ None ☐ Mud ☐ Sludge ☐ Debris ☐ Grease
Silt Depth: **0** (in.) Deposits Extent:
Infiltration: **None** Pipe Seal Cond: **Sound**

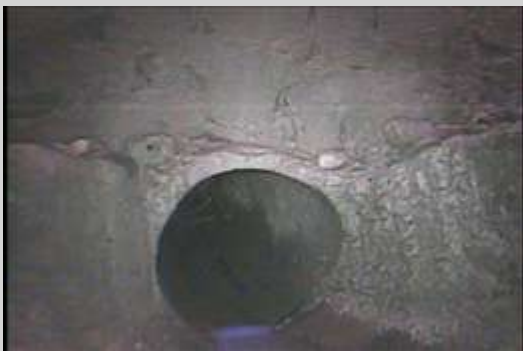
3 O'Clock Inflow

6 in. Circular Gravity Sewer
Pipe In @ 3 O'Clock

Pipe Height: **6** (in.) Rod and Bar (Angled)
Pipe Material: **Clay** ☐ Pipe Lined
Invert Depth: **8.33** (ft.) Flow Characteristics: **Slow**
Deposits: ☒ None ☐ Mud ☐ Sludge ☐ Debris ☐ Grease
Silt Depth: **0** (in.) Deposits Extent:
Infiltration: **None** Pipe Seal Cond: **Unknown**

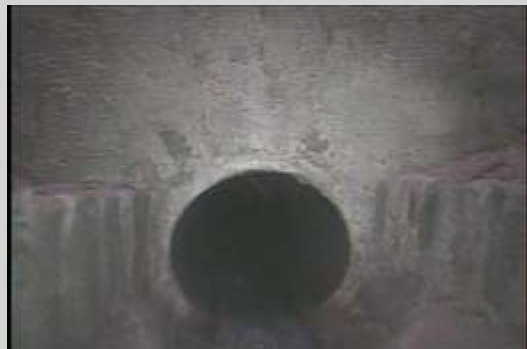
6 O'Clock Inflow

8 in. Circular Gravity Sewer
Pipe In @ 6 O'Clock

Invert Depth: **8.40** (ft.) Flow Characteristics: **Slow**

Pipe Seal Cond: **Sound**
